## Use of Drone Video for Weekly Surveillance at Remote Site Tailings Storage Facilities

Keywords: Tailings Dam, Drone Video, TSF, Remote Monitoring

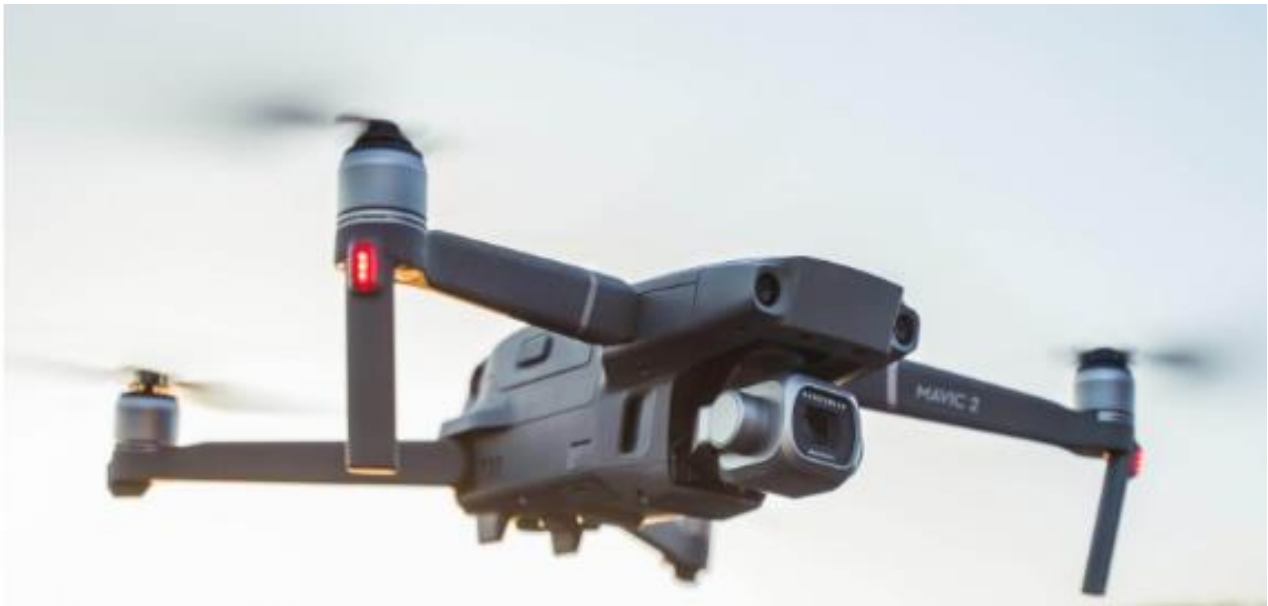
*Figure 1*      *DJI Mavic 2 Pro drone*

A drone is a flying robot or unmanned aerial vehicle (UAV) which is controlled remotely and collects data, such as survey points, video footage and photographs. From a military background, drones have evolved to be used in a range of civilian roles. Typical commercial-use drones are compact in design but can vary in size to aircraft scale. For this project, the drone used was a DJI Mavic 2 Pro (Figure 1), which features omnidirectional vision systems, infrared sensing systems, and a fully stabilized 3-axis gimbal with a 1" CMOS sensor camera that shoots 4K video and 20-megapixel photos. It is capable of connecting to a smart mobile phone for remote screen viewing and to pilot the drone.

This drone is also capable of flight plan mode which can be configured through its device setting depending on the specified location, area and pre-defined pathway.

A Mavic 2 Pro or similar drone retails for approximately A\$3000.

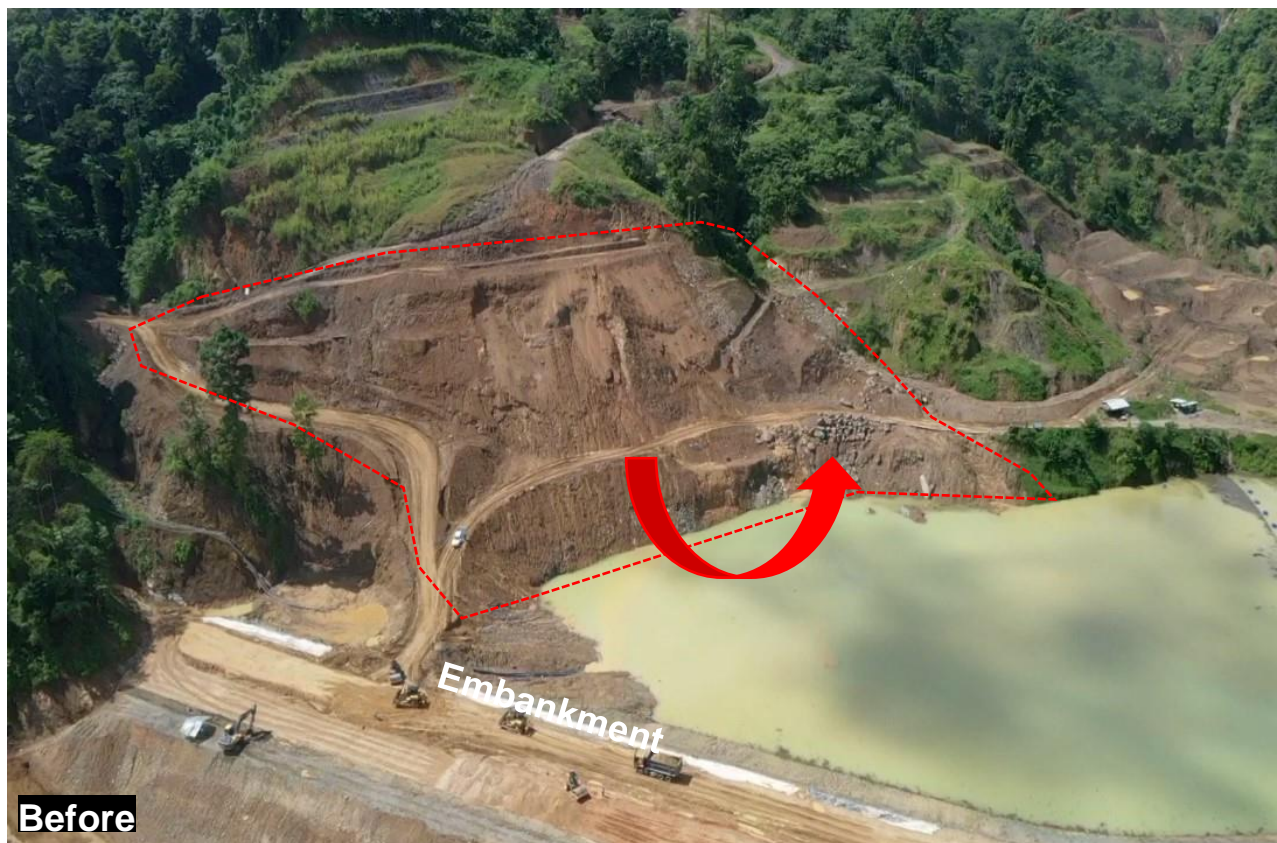
**Figure 2** Upstream batter noted to be potentially unstable

The drone image shown in Figure 2, shows a cut slope located on the right abutment of the impoundment area. This was noted by reviewers as potentially unstable with any failure potentially causing waves that could threaten the embankment. Dam design engineers notified the client of the risks and impact if not corrected immediately.

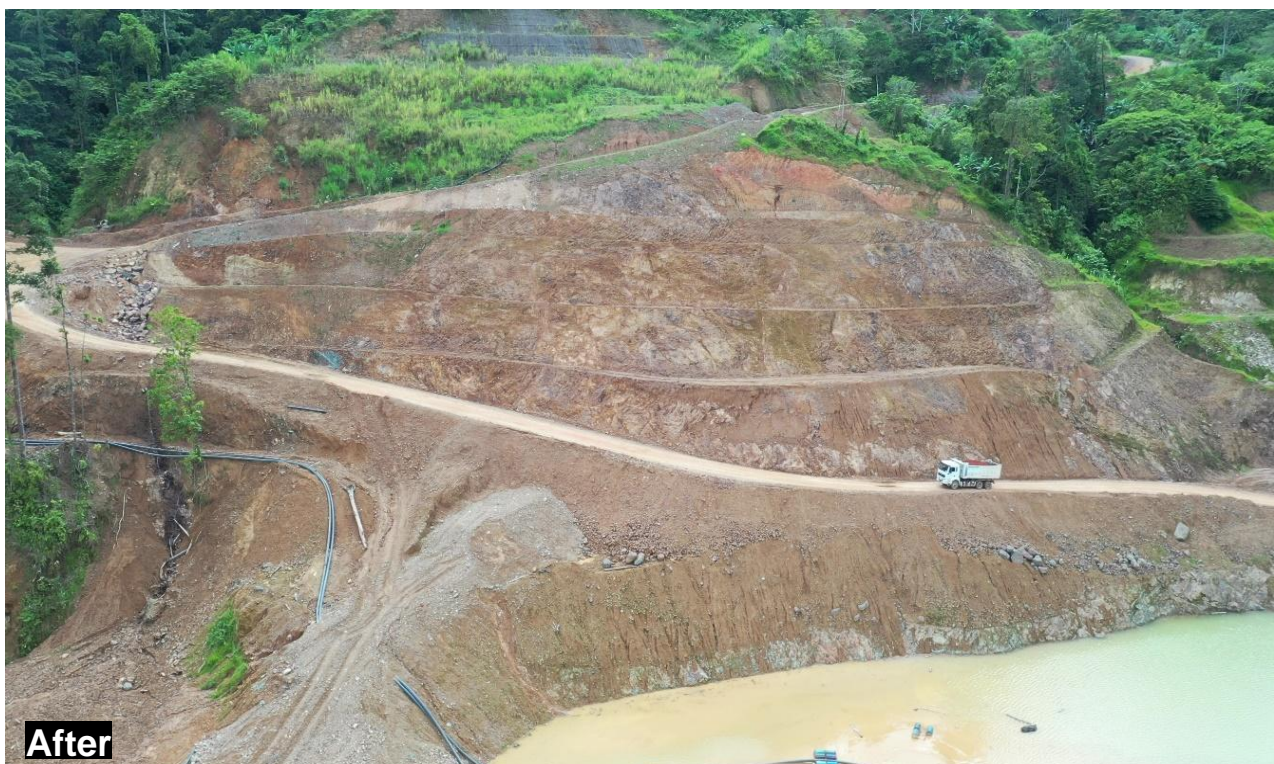
**Figure 3** Batter after stabilisation works.

Remediation works allowed stabilisation of the batter as shown in Figure 3.

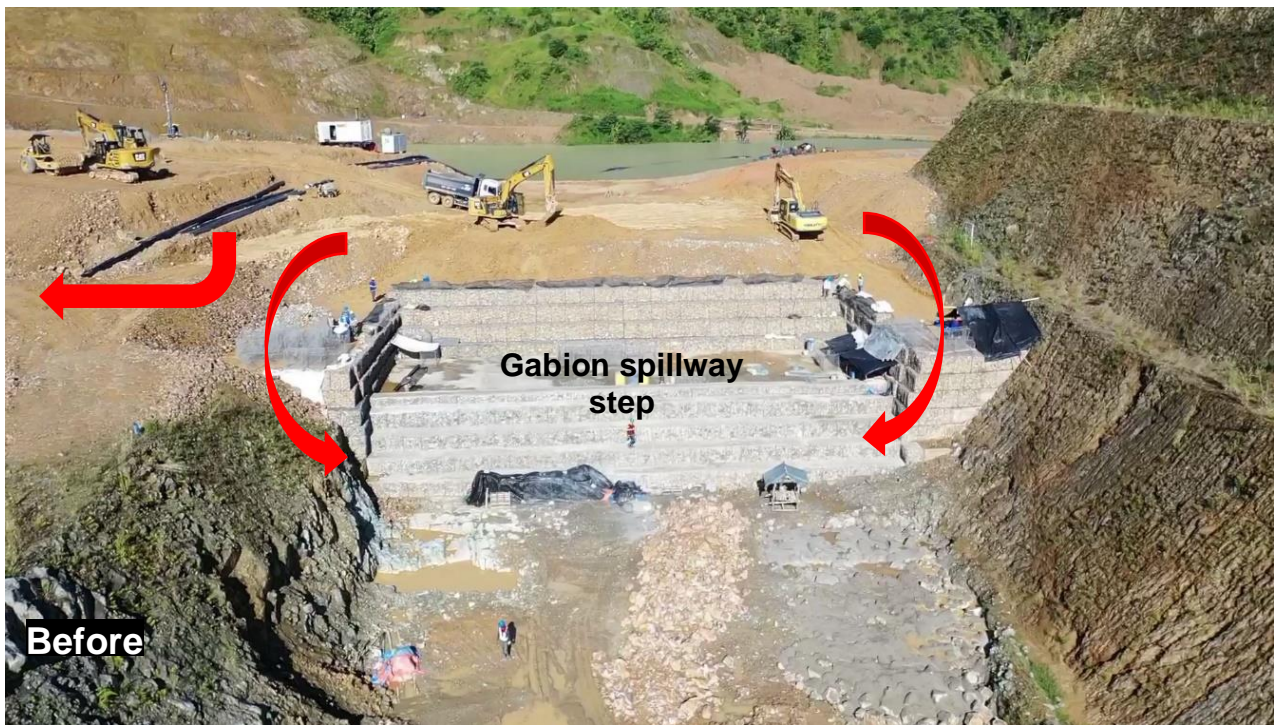
**Figure 4**      *Gabion spillway walls lower than crest*

The drone image in Figure 4 shows the progress of the gabion spillway construction. The gabion spillway was built in stages. The reviewers noted that the raising of the spillway walls was progressing at a lower rate than the spillway crest. This meant that if there was a rise in the pond level leading to overtopping the spillway, there was a potential for unplanned spill to both sides of the spillway leading to damage and potential failure of the spillway. The dam engineers advised the client on the spillway construction sequence, with the mid-section serving as the low point and the gabion sidewall being built in advance resulting in the correct geometry shown in Figure 5 and the completed structure in Figure 6.

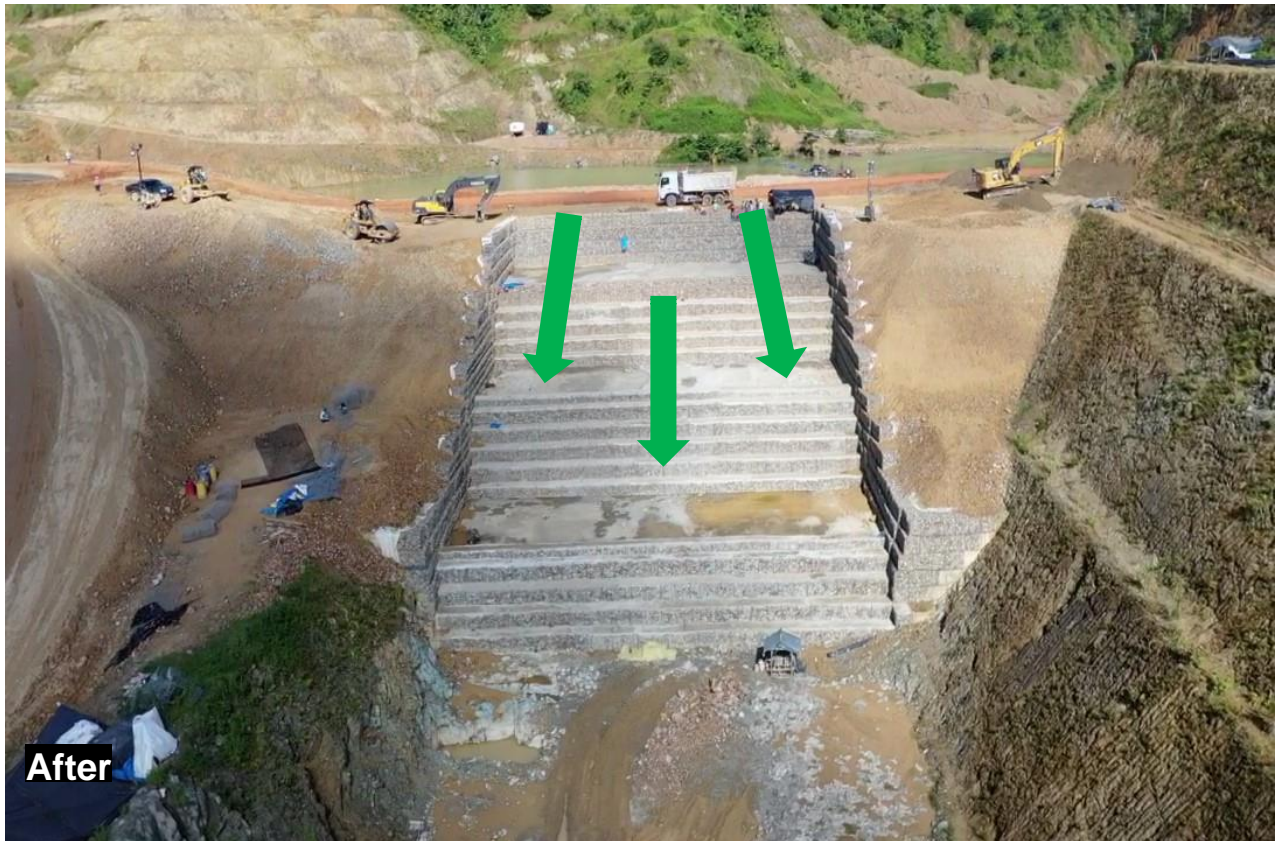
**Figure 5** Properly constructed spillway

The image above shows the sequence of the gabion spillway construction which has been modified based on the recommendations of the dam engineers. This includes the construction of the gabion side walls before the gabion steps to ensure that the flow is directed into the middle portion of the spillway in case of an overtopping event.

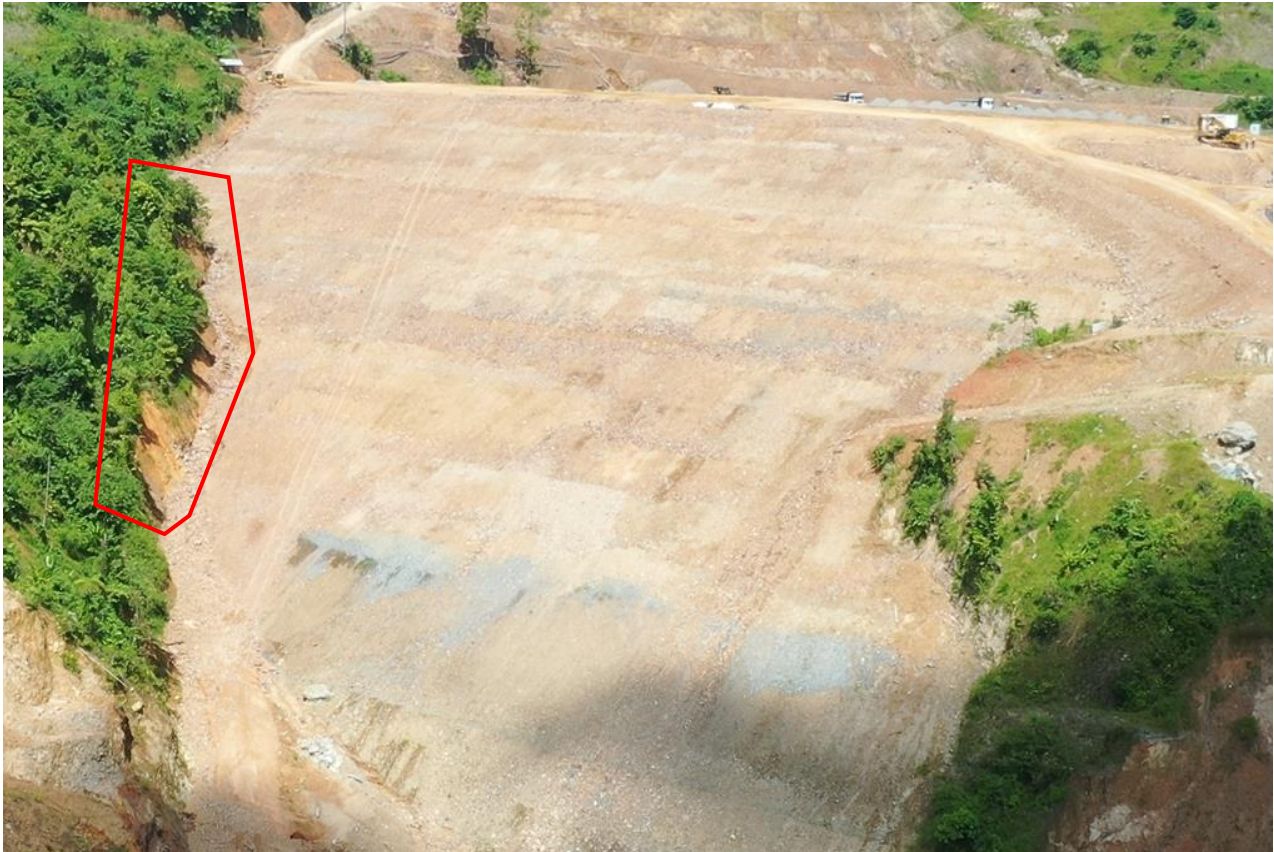
**Figure 7**      *Significant erosion on right abutment*

The drone image in **Error! Reference source not found.** shows erosion along the right abutment caused by surface run-off. Dam designers informed the client of the potential risk for instability if the erosion progresses further. **Error! Reference source not found.** shows the remediated scouring along the South abutment. Surface run-off was also diverted away from the abutment to prevent erosion from subsequent rainfall events.
